**CLASS IVb
SOLID WASTE LANDFILL
PERMIT APPLICATION**

**DAVID MADSEN
Madsen Landfill**

February 2010

**Savage Surveying, Inc.
1925 South Industrial Park Road
Richfield, Utah 84701**

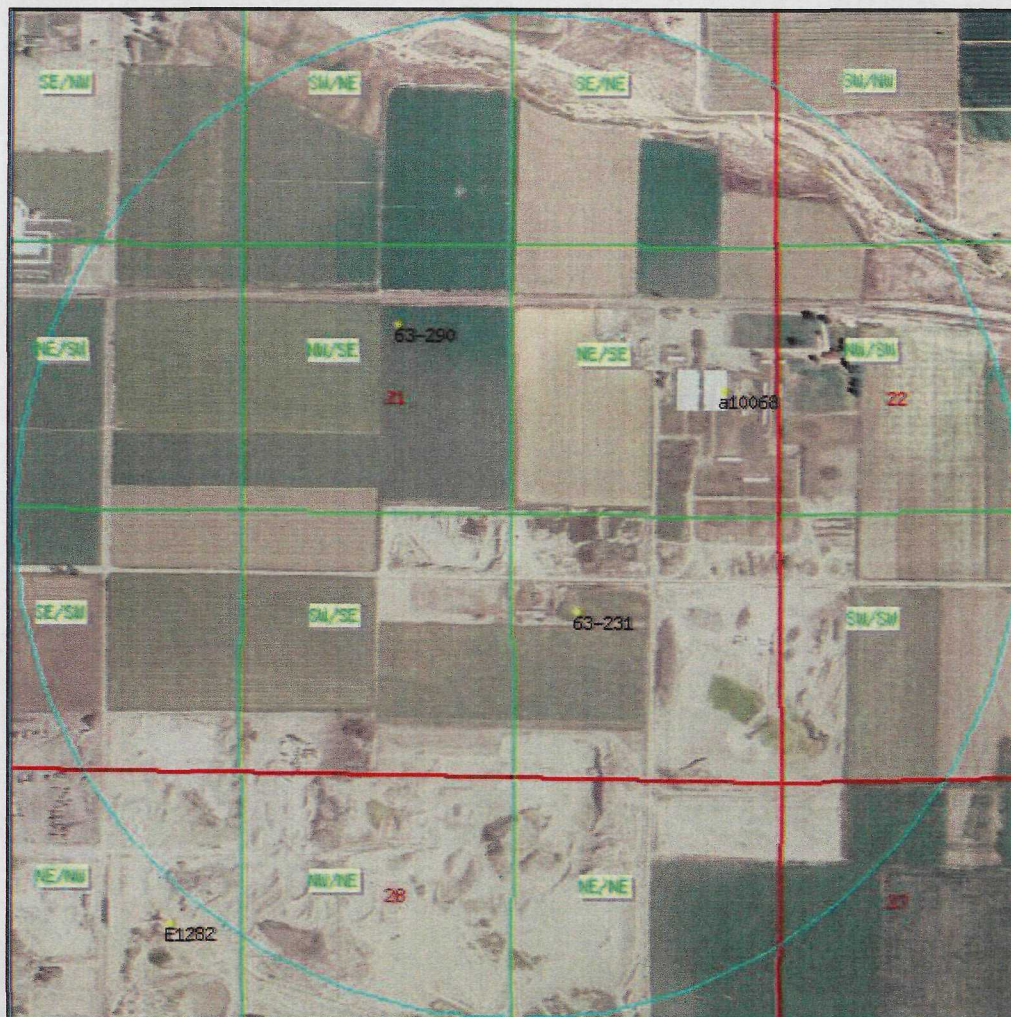
Radius search of 2500 feet from a point N1320 W1320 from the SE corner, section 21, Township 19S, Range 1E, SL b&m Criteria:wrtypes=W,C,E podtypes=S,U,D,Sp,P,R,T status=U,A,P usetypes=all

Search of the Division of Water Rights records shows that there are three wells located within 2500 feet of the landfill site. The closest well is a stockwater well located approximately 300 feet south of the site. The water rights information is included in Appendix C.

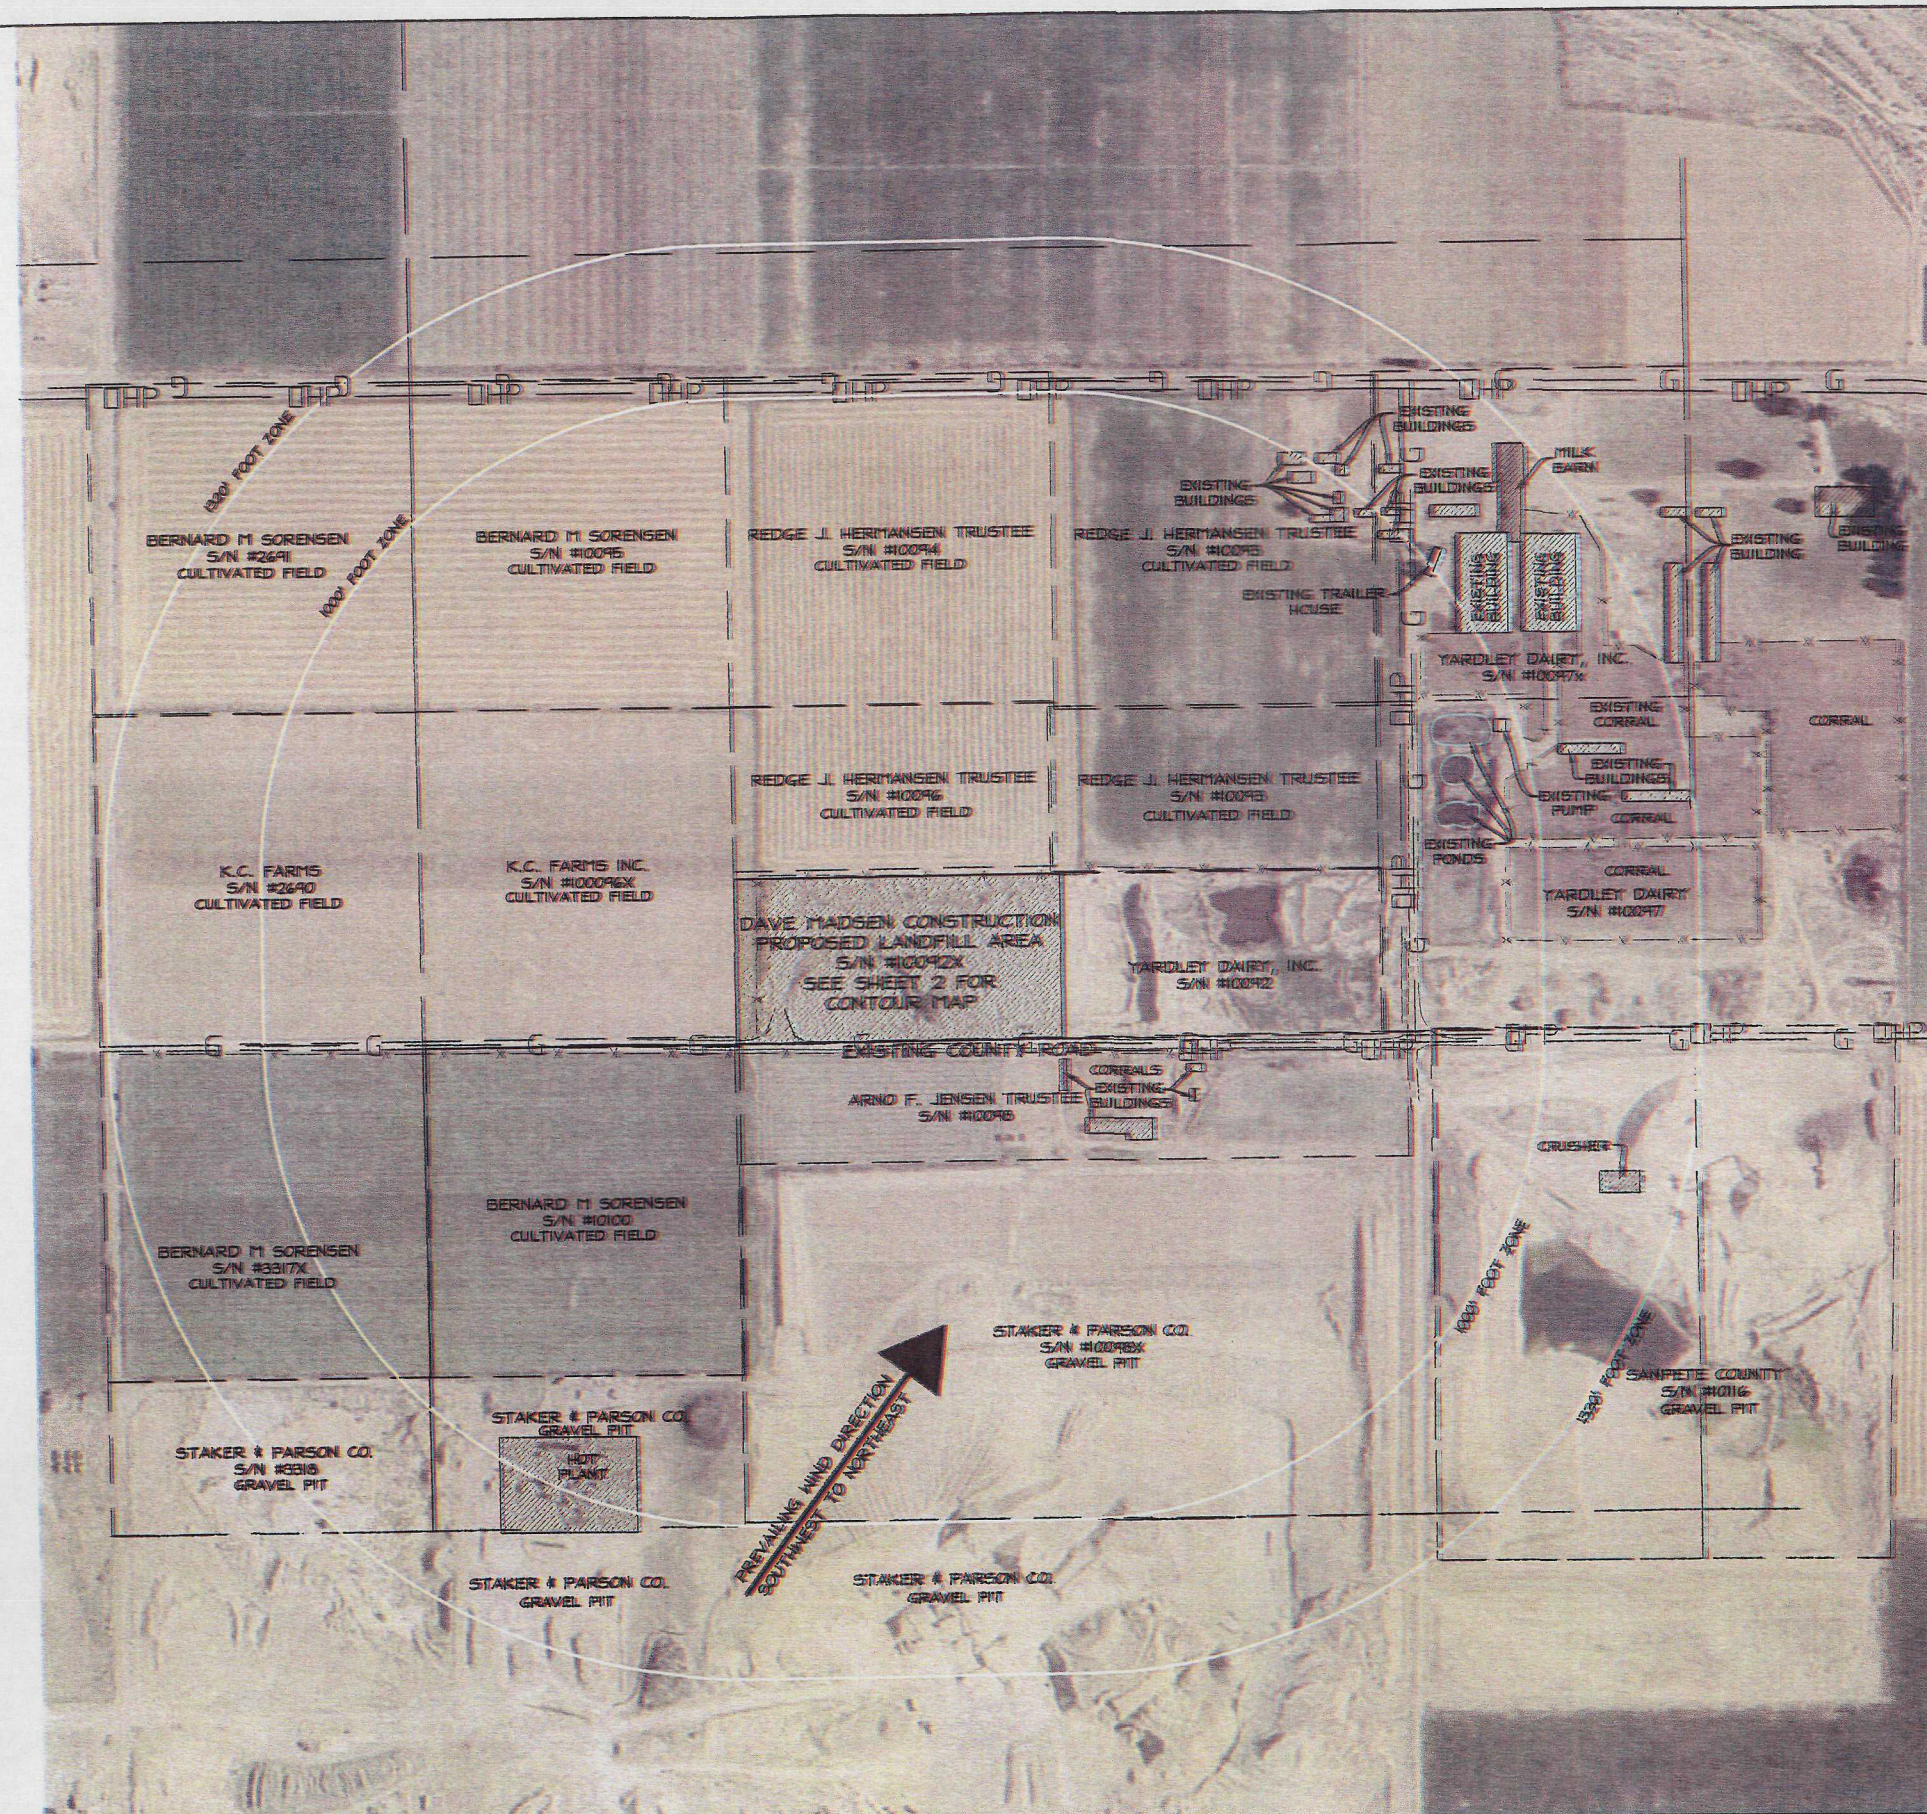
ENGINEER T.M.	SCALE 1"=50'	SHEET NO. 1 OF 3
CHECKED RWS	PROJ# 0907-016S DWG.NM: 0907-016S	
DRAWN ASA	DATE 01/28/2010

1000 FOOT ZONE	
RESIDENCES	1
PARKS	0
MONUMENTS	0
RECREATION	0
WILDERNESS	0
HISTORICAL STRUCTURES	0
OTHER STRUCTURES	13

1320 FOOT ZONE	
RESIDENCES	1
PARKS	0
MONUMENTS	0
RECREATION	0
WILDERNESS	0
HISTORICAL STRUCTURES	0
OTHER STRUCTURES	24

EXHIBIT MAP FOR
DAVE MADSEN LANDFILL
